EXISTING CONDITIONS SUMMARY REPORT

6/16/2012

River S Unit access road – Ridgefield, WA

Summary and discussion of the existing conditions for the current River S Unit access.

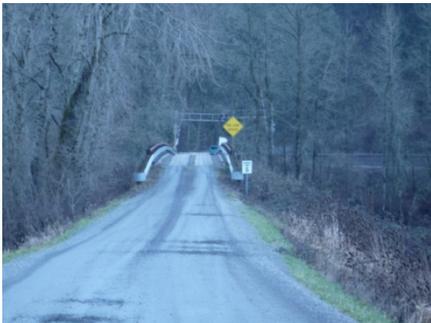
The most recent bridge appraisal was completed in 2010. This report characterized the overall bridge condition as Fair. The condition assessment is based on conditions of the deck, superstructure, approach elements, channel elements and substructure items. The report estimated a remaining life to be 5-10 years – which is based on current load capacity, without major repairs or rehabilitation. Another way to say this is that it is highly likely that within the next 5 to 10 years, a major repair or rehabilitation will be necessary to keep this bridge in service.

The majority of the timber piling that compose the trestle bents have been in place since the bridge was built. These piles are considered to be in poor condition with moderate to heavy rot above the water line. Although it is not an immediate need, it is likely that rehabilitation of these elements would be needed within the next 5-10 years.

The bridge has a sufficiency rating of 44.7% (as of 2010 inspection). This ranks the bridge 8th/44 regionally and 35th/290 nationally within the USFWS inventory. (100% is an entirely sufficient bridge and 0% is an entirely deficient bridge).

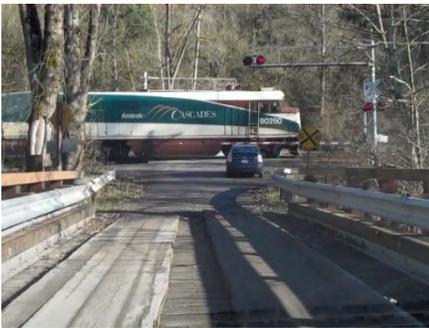
The railroad crossing is a 2 track timber crossing with 2 mast mounted gates with warning lights and a bell. There are also two cross bucks and advanced warning signs leading to the crossing. The crossing serves both commercial trains and passenger trains (11 total train crossings per day- per AMTRAK train schedule as of March 14, 2012), with a total of 57 total trains per day. The speed of the trains along this stretch of track range from 1 to 79 mph. The track is owned and operated by Burlington Northern Santa Fe (BNSF). Union Pacific (UP) and AMTRAK also utilize the tracks. This location is not in a quiet zone as defined by the BNSF railroad.
