**Federal Highway
Administration**

Date: April 9, 2012

Subject: Geotechnical Condition Assessment
Ridgefield Wildlife Refuge
River S Unit Access Project
WA RRP RIDG 100(2)

Geotechnical Memorandum No. 08-12

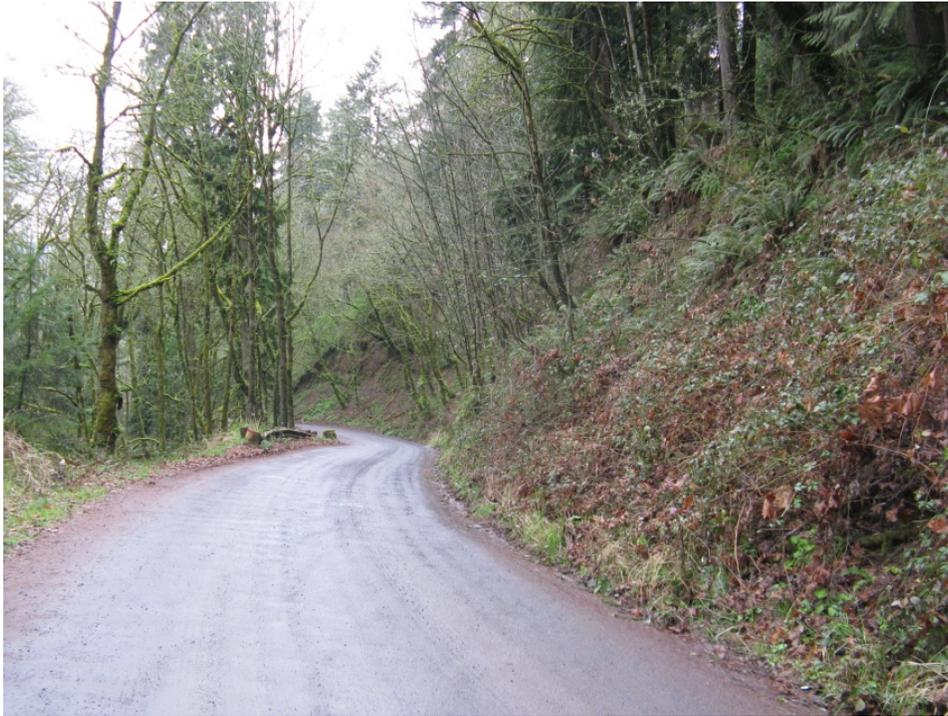
The existing road template appears to have generally been constructed with a partial cut bench on the uphill side and a fill on the downhill side. Both the cut and fill slopes are relatively steep with slope angles ranging from 40 degrees (1V:1.2H) to vertical. Natural slopes within the drainage were generally between 30 degrees (1V:1.75H) to 40 degrees (1V:1.2H). A photograph of a typical roadway section is shown in **Figure 5**.

Figure 5. Photo of Typical Road Section, Looking Northwest (towards Lake River).

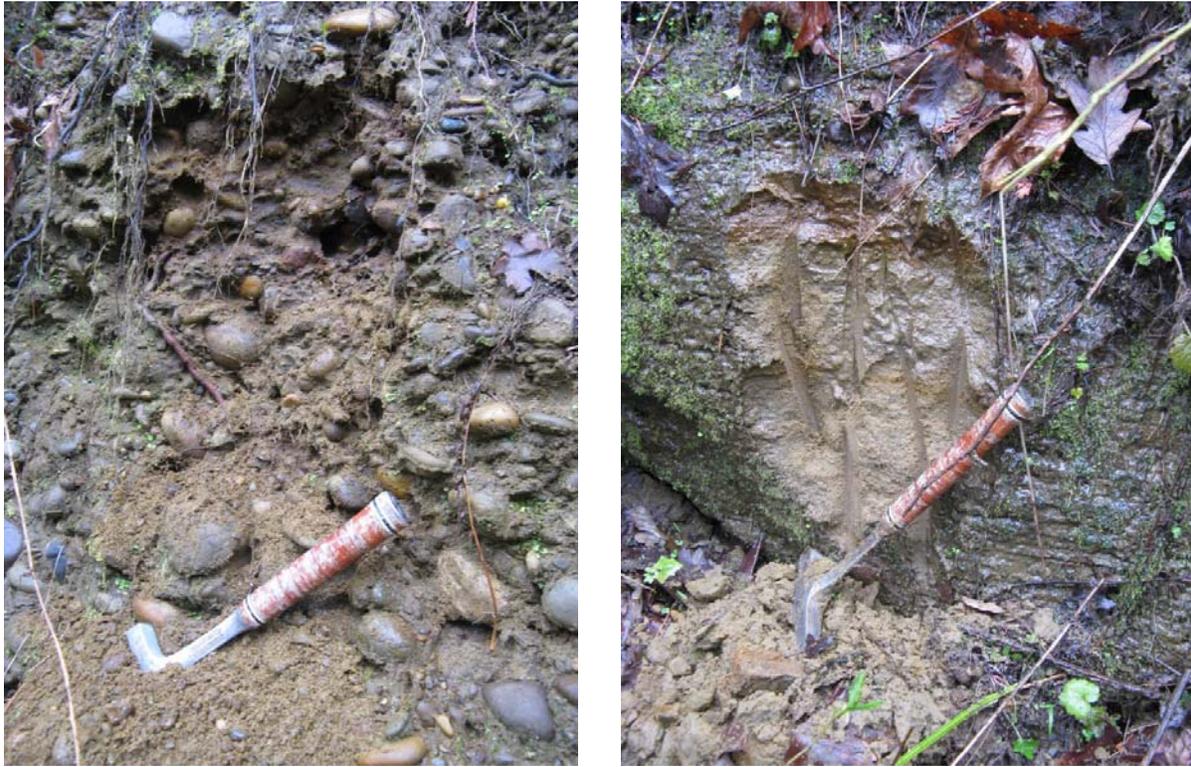
The soil types observed in the existing cut slopes were consistent with the descriptions on the geologic map. Near the top of the hill the soils exposed were visually classified as silt with some clay, moist, brown, low plasticity. Further down the road the steeper and higher cuts exposed conglomerate that was visually classified as gravel and cobbles in a fine to medium grained silty sand matrix, subrounded to round gravel and cobbles, 6-inch minus. Near the lower end of the alignment a layer of weakly cemented fine to medium sand with silt was

observed underlying the conglomerate. Seepage was observed in this area just above the contact of the two layers. See **Figure 6** below.

Figure 6. Photos of conglomerate (left) and sand (right) layers.

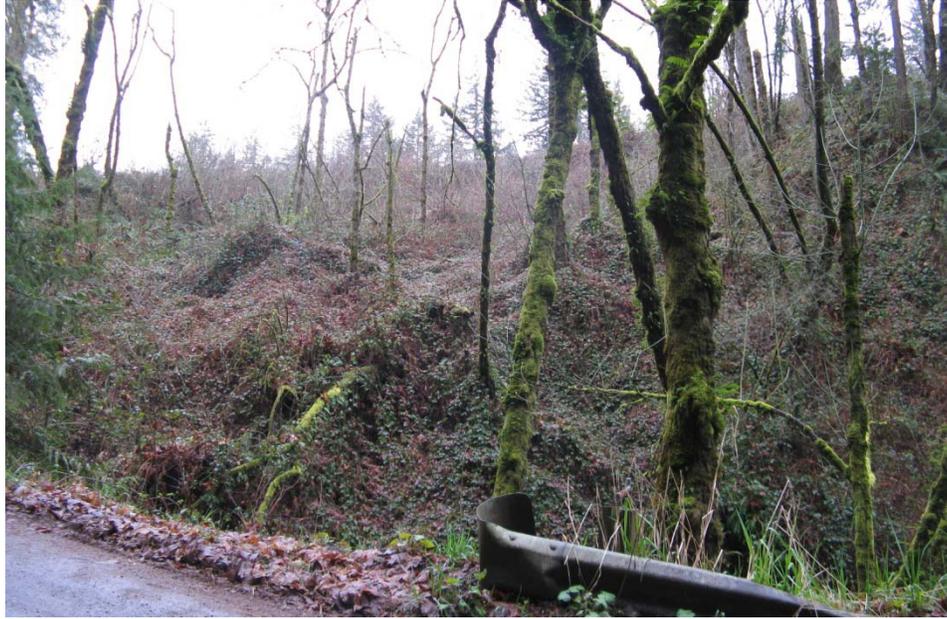
A fairly significant landslide was observed on the opposite side of the drainage from the road. See location of landslide in **Figure 1** (attached) and photo of landslide in **Figure 7**. The landslide encompassed an area of about one acre. It appears from the age of the trees on top of the slide mass that it occurred within the last 20 years. The slide is not impacting the roadway; however, if continued movement dams the drainage, it could cause significant flooding and erosion or a larger failure that could have significant impacts to the existing road.

Figure 7. Landslide Observed Across Drainage from Refuge Access Road.

The shallow slumps and also the larger landslide previously mentioned are commonly observed throughout this geologic formation mapped as conglomerate by Evarts (2004). As previously stated, this formation is often included as part of the Troutdale Formation. The formation consists of very dense and slightly cemented gravel and cobbles so it will stand at vertical slopes as observed along this road. However, when the material becomes saturated it loses significant strength often resulting in landslides ranging from shallow slumps to massive ground movements; both observed with the drainage that the Refuge access road follows. Slopes in the conglomerate are sometimes cut vertical to minimize the amount of precipitation that directly impacts the slope. Once the slope deviates from vertical it must be laid back to an angle that will be stable considering the amount of precipitation that it will be exposed to. Generally these materials would be stable at slopes of 1V:1.5H or flatter.

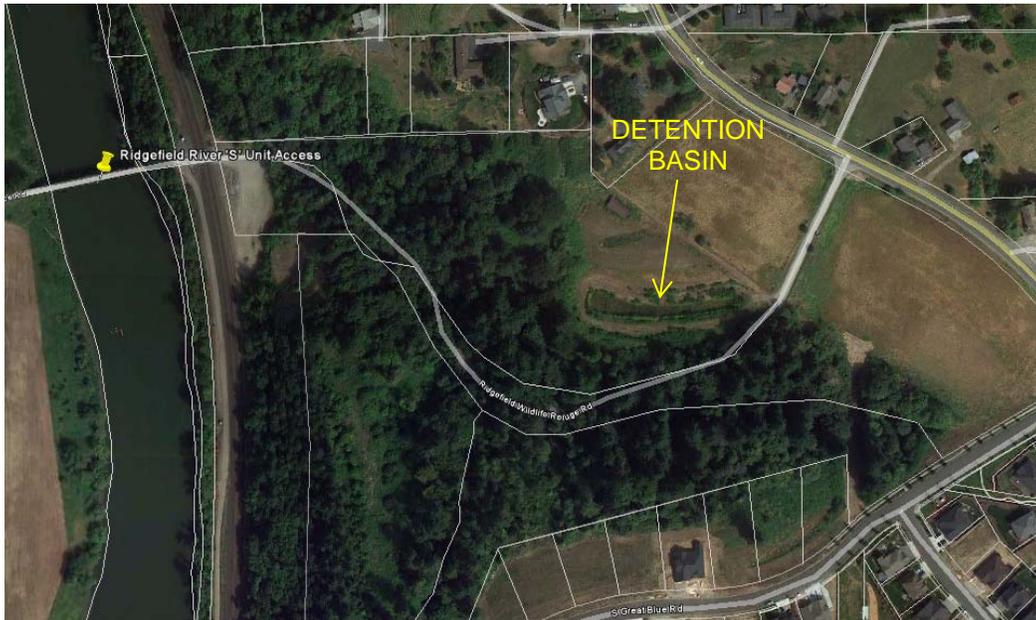
A detention basin was observed on private land near the intersection with Hillhurst Road. See aerial photo in **Figure 8** showing its location. The detention basin is situated on the level

ground at the top of the slope above the road. It was not inspected since it is on private property.

Storage of water, even if temporary, at the top of a slope can raise the local groundwater table and increase the likelihood of landslides.

Figure 8. Aerial Photograph of Refuge Access Road (2012 Google Earth).

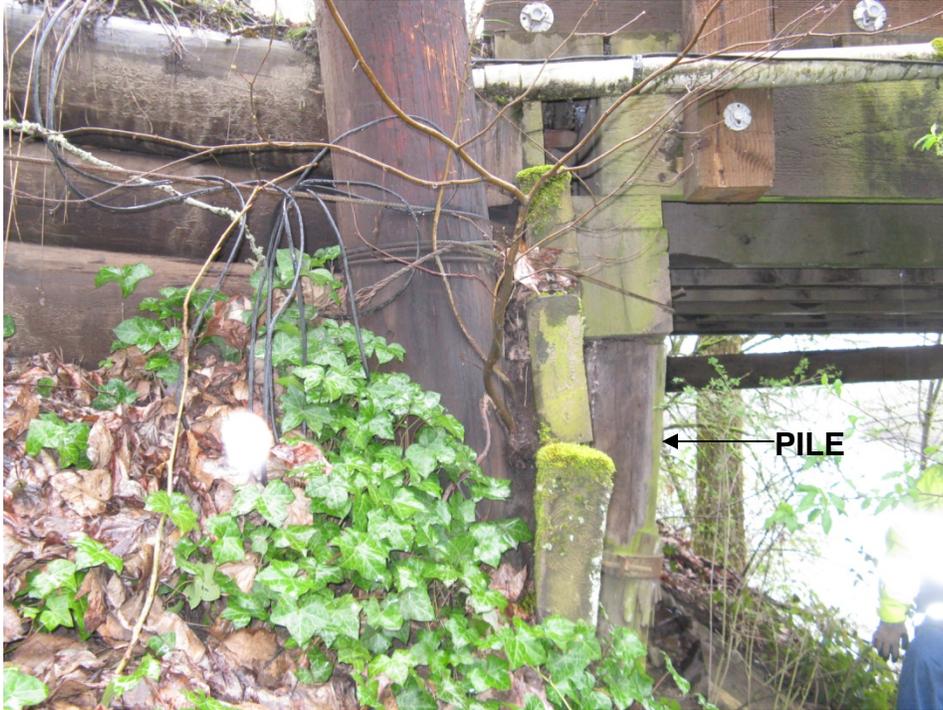
The west abutment was reconstructed between 2008 and 2010 and the piles and cap appeared to be in good condition. The timber piles, pile cap, and wingwall at the east abutment had moderate to heavy rot (as documented in the 2010 Bridge Inspection Report). The piles, pile cap, and wingwalls also exhibit visible rotation (See **Figure 9**). The piles in the river were not accessible, but the Inspection Report also indicates moderate to heavy rot in the piles above the water line.

This bridge was originally constructed in 1970. The durability of timber piles is a function of the site conditions. The durability is most effected when timber piles are subjected to alternate wetting and drying cycles that leads to damage and decay by insects.

Figure 9. Picture of East Abutment, note Pile Rotation.

Data from a USGS gage station on the Refuge Road access bridge indicates that the water level of the river fluctuates twice daily with magnitudes up to 2 feet. This is interpreted to be related to tidal influence. Due to the highly variable water level and the observed rot the piles should be considered to be in a marine environment when interpreting the durability and the expected service life should be 50 years.

Considering the short spans and the relatively lightweight superstructure, it is interpreted that the piles have relatively small loads. However, since the piles are nearing their expected service life and there is observed moderate to heavy rot an analysis of the pile loads versus the remaining pile capacity is recommended. The remaining pile capacity could be established following an inspection and coring of the piles in the river. This should be done during low water so the cores can be taken in the zone that experiences the most fluctuation in water level.
